NELSON – RRD 2025

Novel Acetabular Hemiarthroplasty for Palliation of Periacetabular Metastatic Disease with Articular Bone Loss

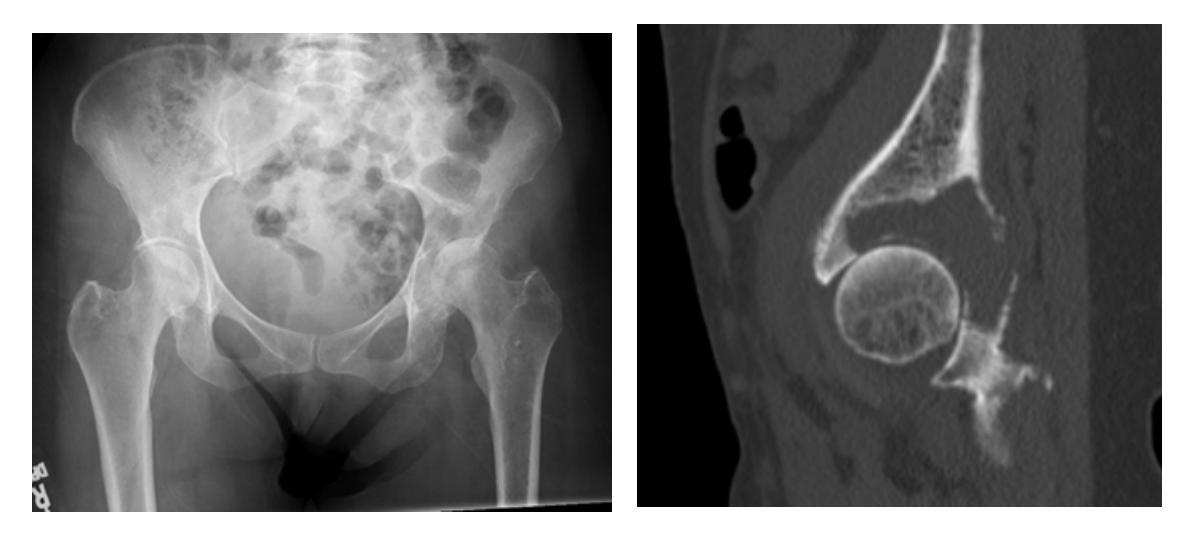
Figure 1. Case 1- periacetabular thyroid cancer metastasis. (a) AP pelvis radiograph demonstrating cephalad migration of the femoral head, (b) CT with sagittal reconstruction showing involvement of superior dome and posterior column.

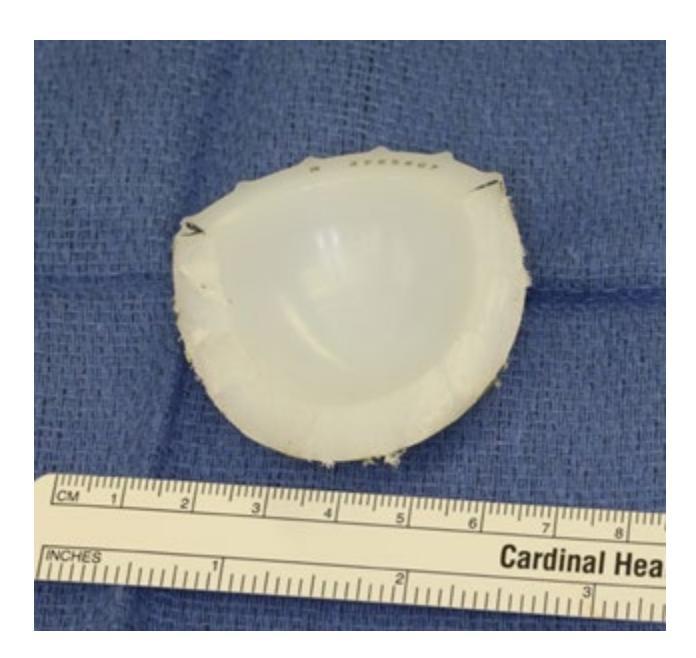
Figure 2. Total hip polyethylene acetabular liner portion used to restore missing articular surface. Approximately 2/3 of the liner is discarded.

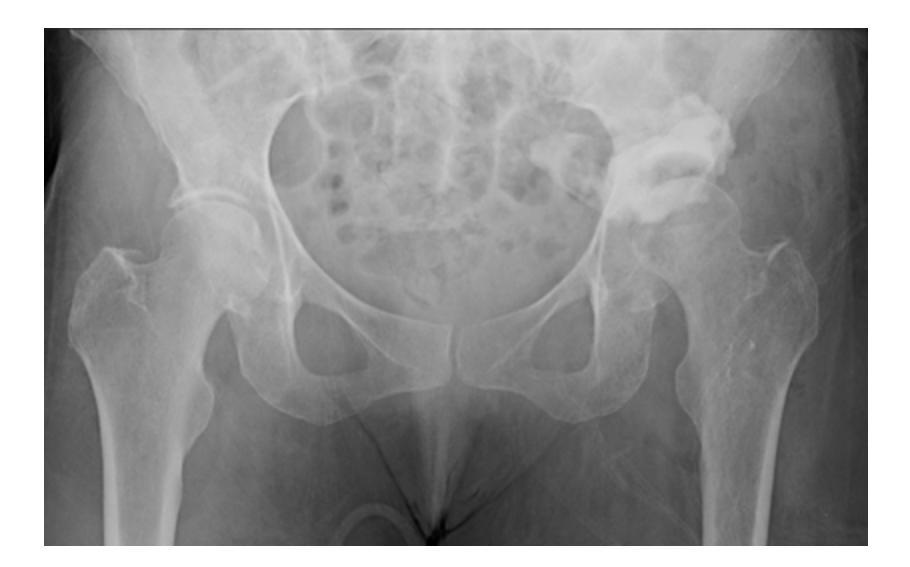
Figure 3. Case 1 postoperative AP radiograph of the pelvis demonstrating cemented polyethylene liner portion within the acetabulum. Despite the mild persistent superior hip joint subluxation, the patient reports minimal pain.

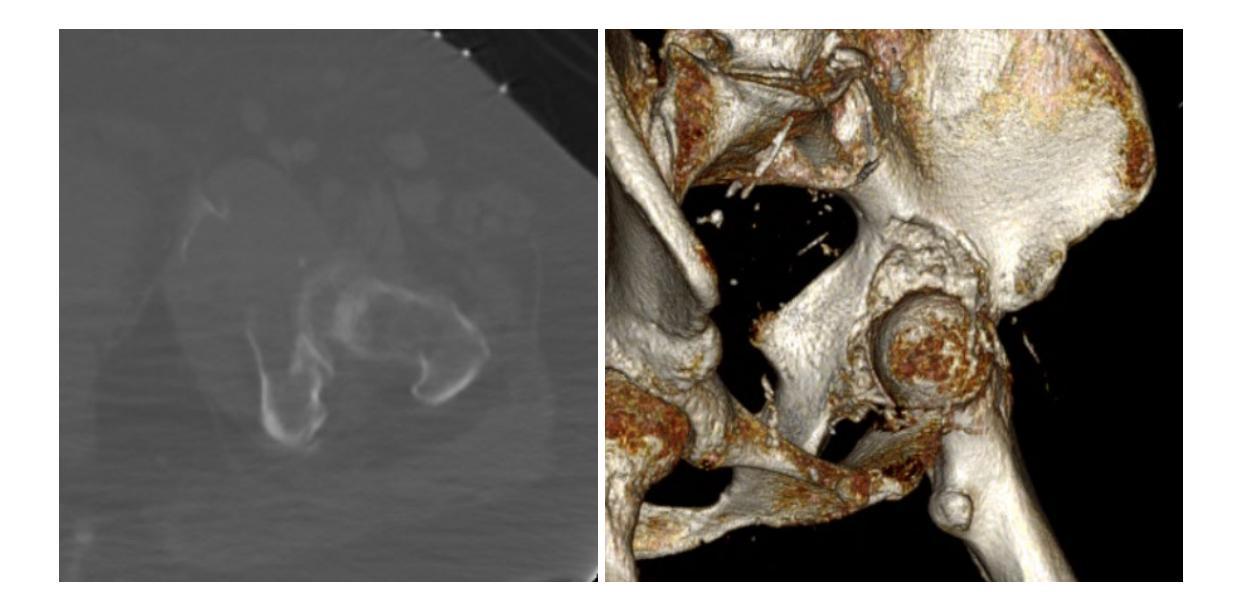
Figure 4. Case 2 - periacetabular metastatic endometrial cancer. (a) CT axial and (b) 3D reconstruction views demonstrating destruction of medial acetabular wall and anterior column.

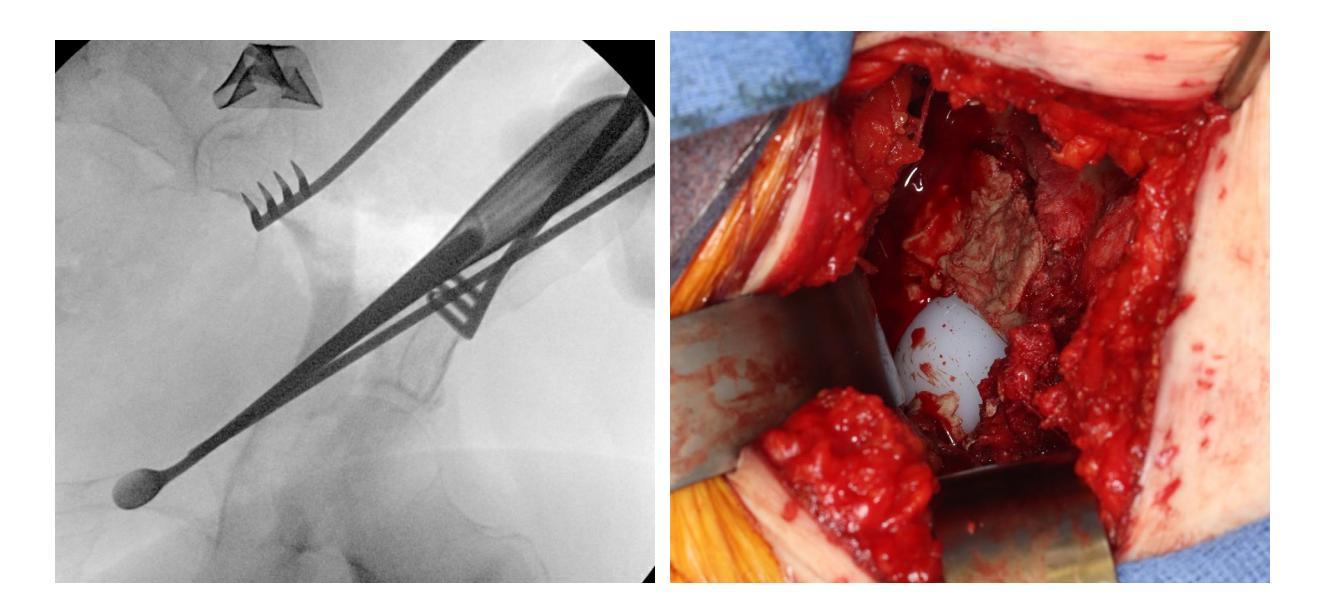
Figure 5. Case 2 intraoperative images. (a) Fluoroscopy of tumor curettage and (b) photograph of completed reconstruction showing thick liner protruding beyond the medial wall.

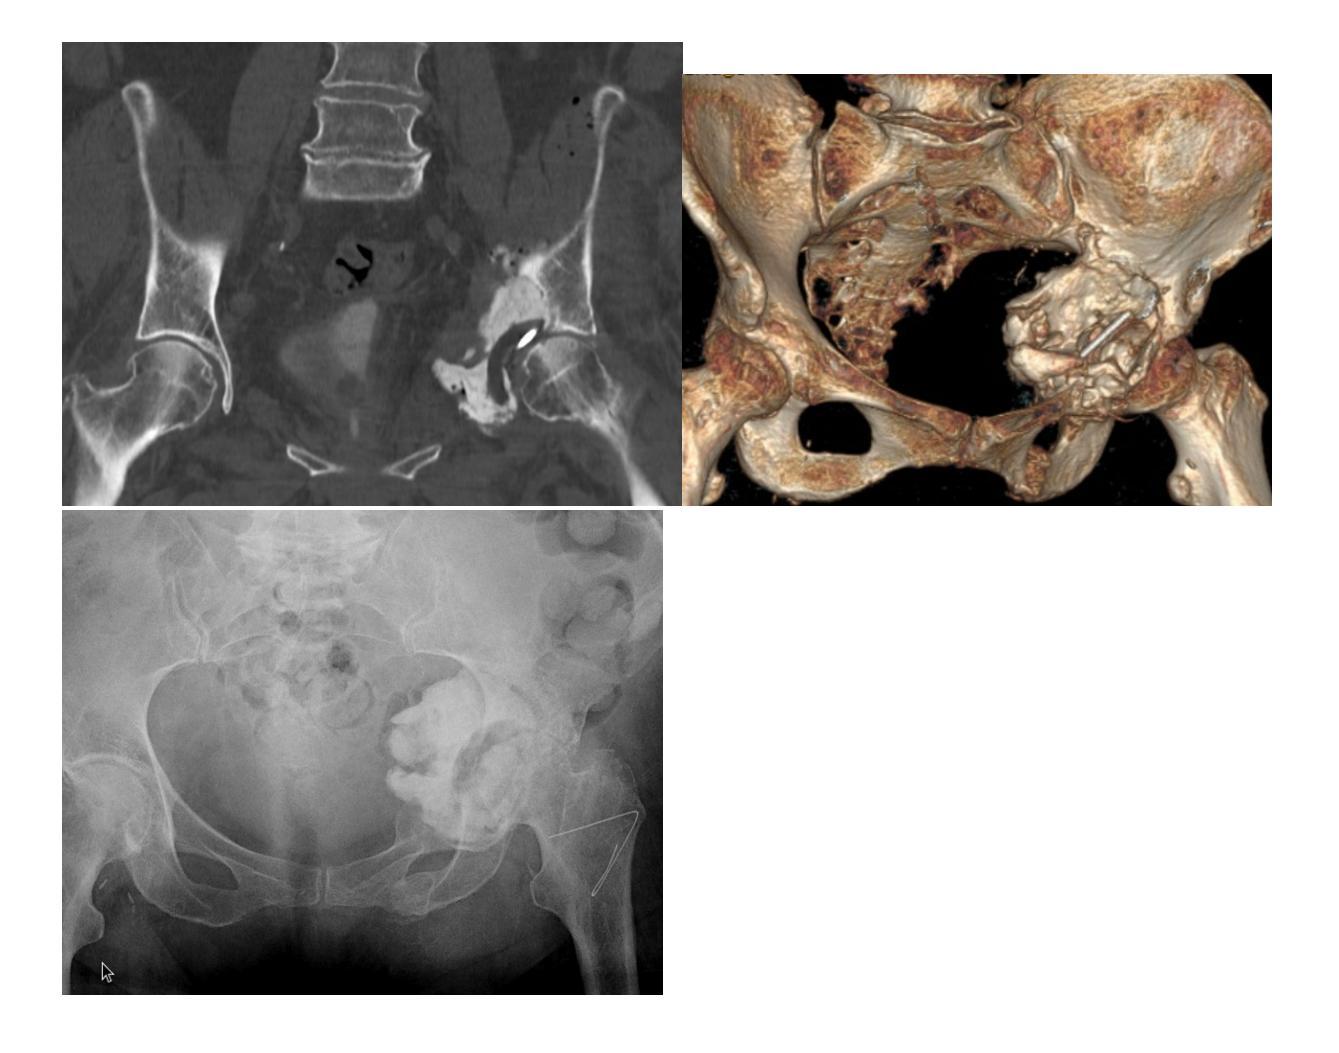
Figure 6. Case 2 postoperative CT imaging (a) Coronal and (b) 3d reconstruction views demonstrating radiolucent acetabular liner portion, methyl methacrylate and Steinman pin and (c) radiograph at 21 months largely unchanged with pin removed, restored anterior column bone and mild degenerative changes of the femoral head.

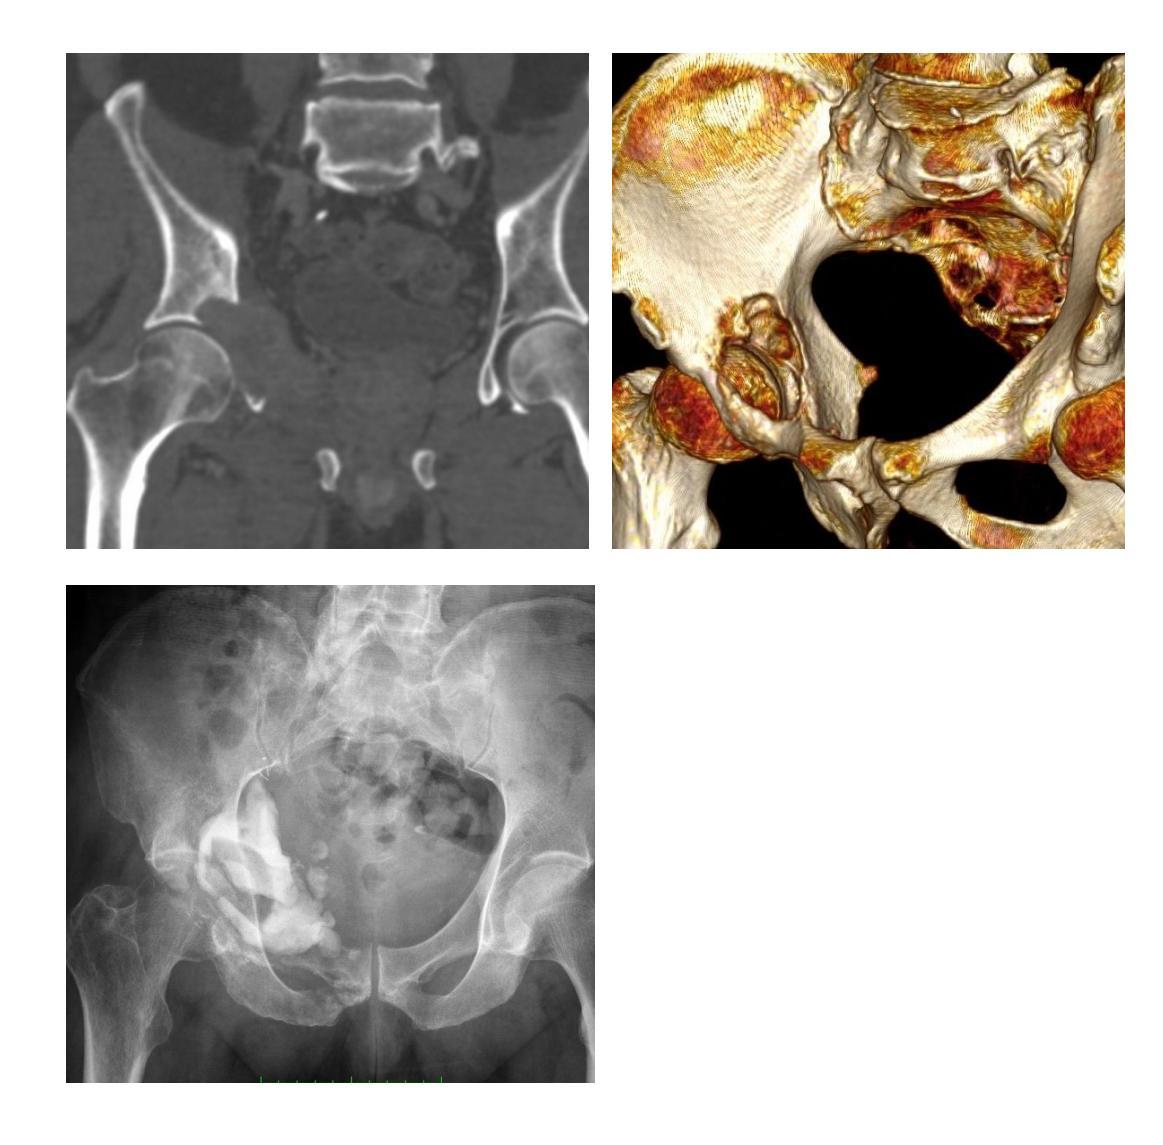
Figure 7. Case 5 - metastatic head and neck cancer. Preoperative CT (a) coronal reconstruction and (b) 3d reconstruction demonstrating loss of medial wall and portion anterior acetabulum column. (c) Postoperative pelvis radiograph showing cemented polyethylene acetabular liner portion.
